BONDSVILLE UPPER DAM
FOLLOWUP INSPECTION REPORT

Dam Name: Bondsville Upper Dam
State Dam ID#: 7-12-239-5
NID ID#: MA00560
Owner: Belchertown Land Trust, Inc.
Town: Palmer, MA
Consultant: Fuss & O'Neill, Inc.
Date of Inspection: May 28, 2010

**Commonwealth of Massachusetts
Department of Conservation and Recreation
Office of Dam Safety Poor and Unsafe Condition Dam Follow-up
Inspection Form**

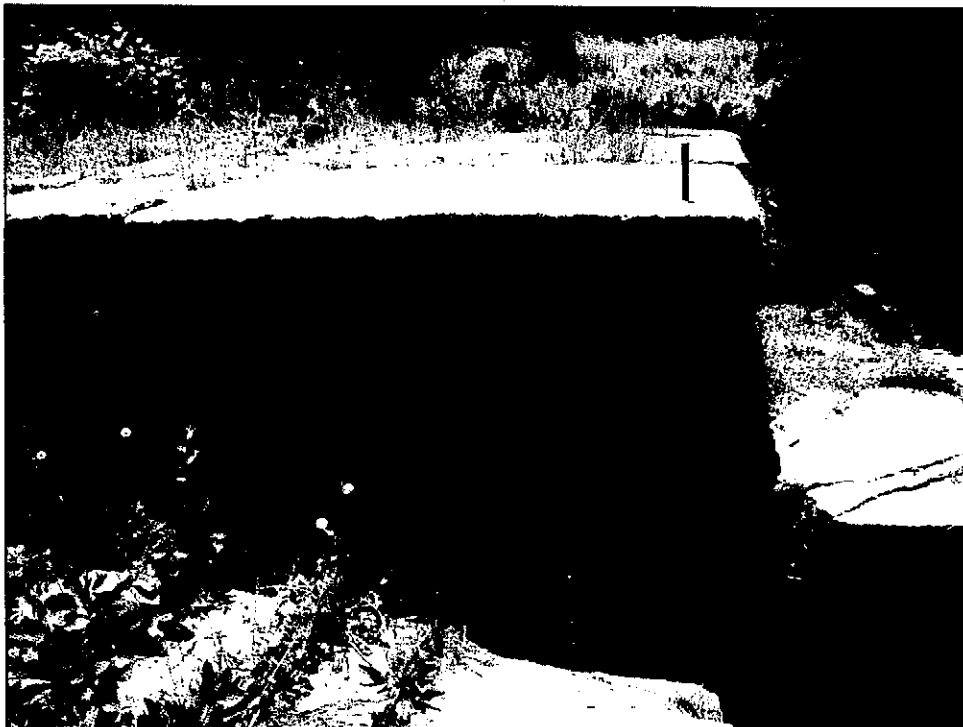
Photo 12: Primary spillway left training wall, first of two photos (downstream end). Note missing masonry blocks.

- Replace missing masonry blocks in primary spillway left training wall / auxiliary spillway right training wall. Repair mortar in masonry adjacent to spillways.

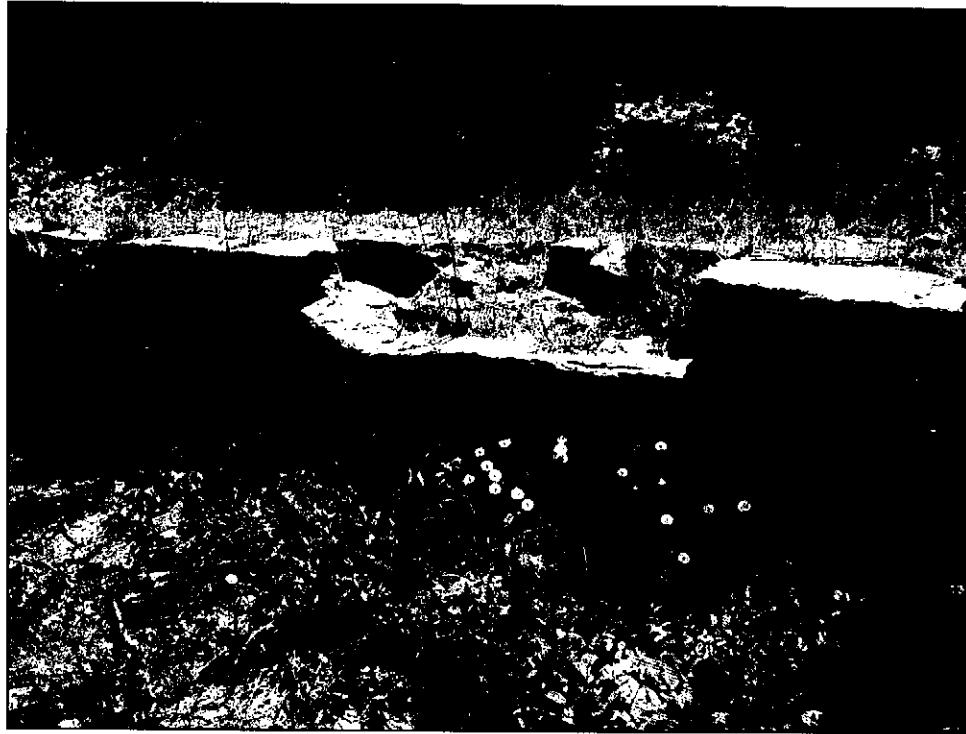
Photo 13: Primary spillway left training wall, second of two photos. Note missing capstone.

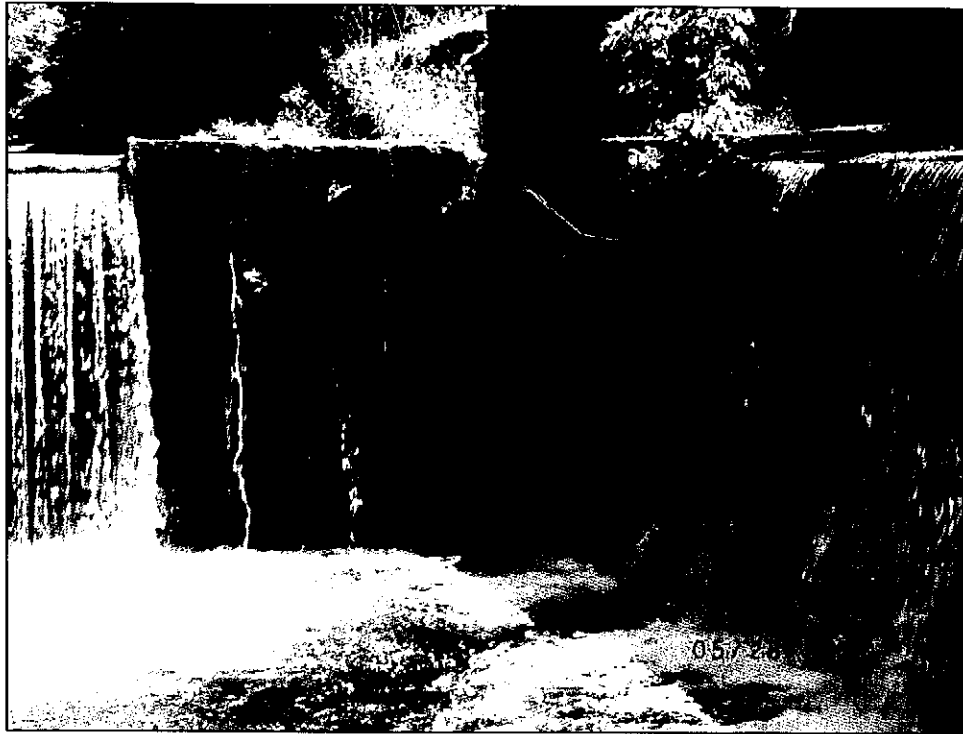
Photo 25: Primary (photo left) and auxiliary (photo right) low-level outlet discharge points. Note discharge from leaking/partially open auxiliary outlet.

- Evaluate condition and operational status of outlet sluiceways and operators, and repair/restore to full functionality.
- Investigate seepage through the downstream masonry face of both spillways.

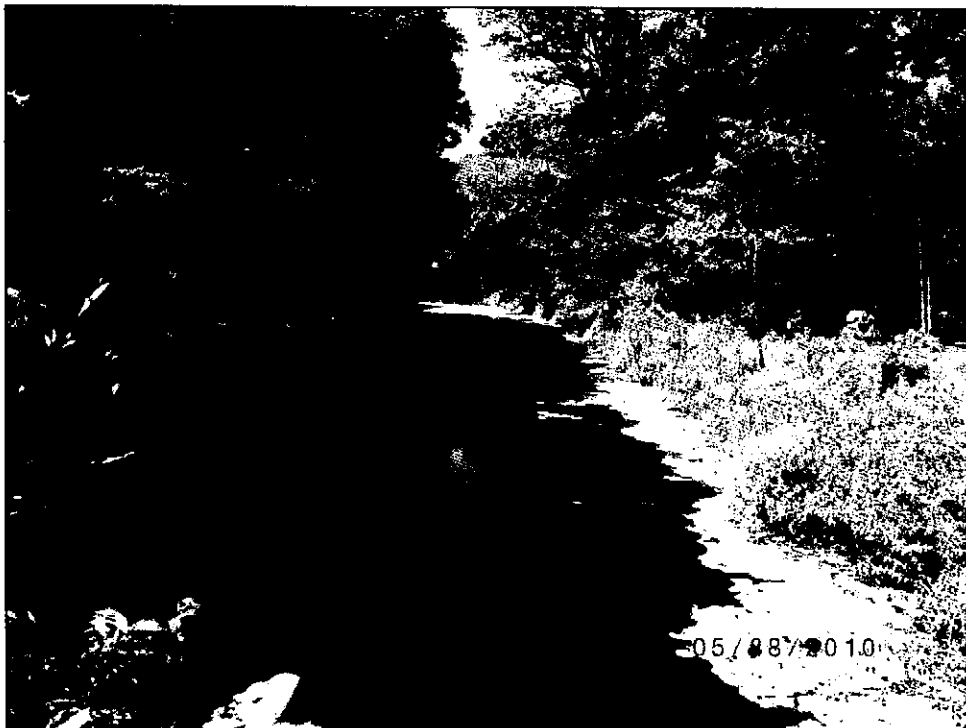
Photo 28: Overview of historical canal facing downstream, viewed from embankment fill. Note PVC pipe for conservation flow.

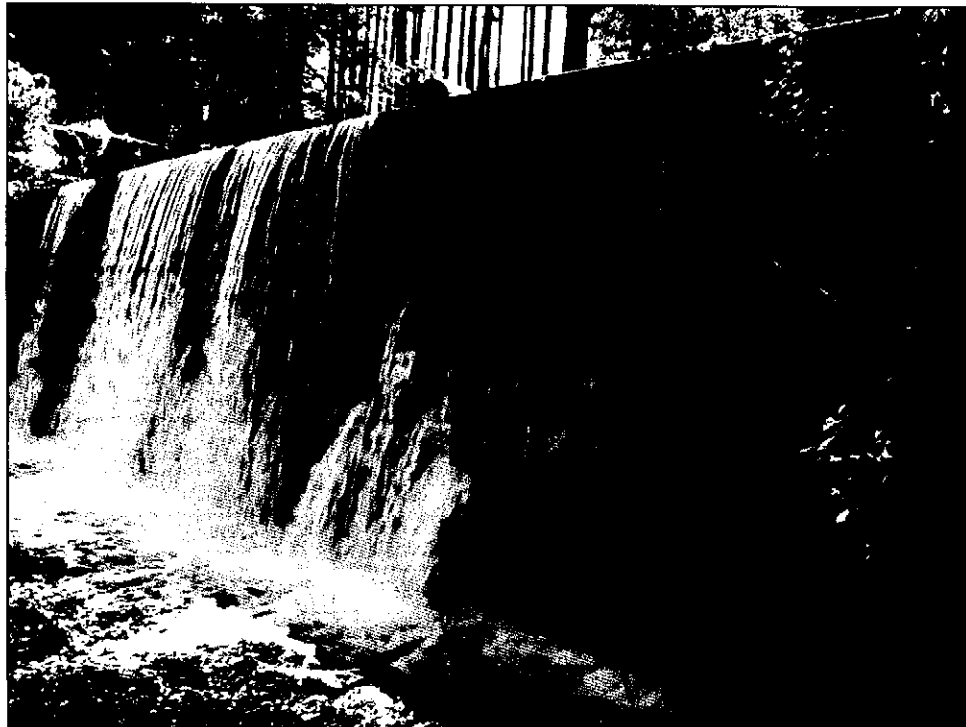
Photo 32: Water leaking through the auxiliary spillway downstream masonry face
