# PRESENTATION

## Assessment of the Upper Bondsville Dam, Swift River Belchertown, Massachusetts

MILONE & MACBROOM®  
September 30, 2010

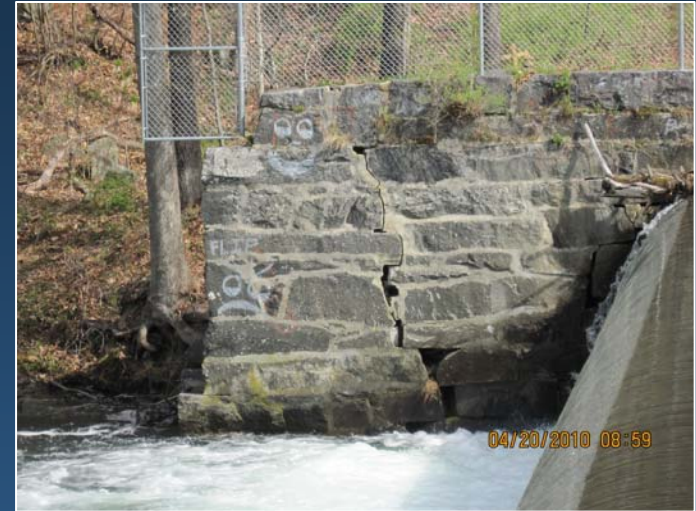
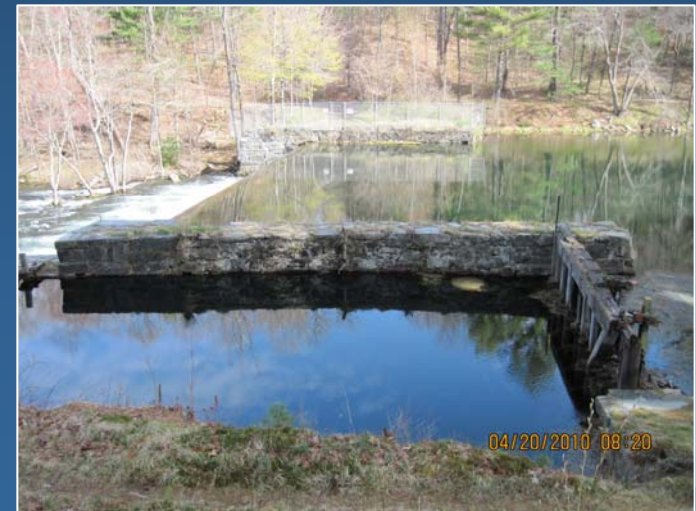
# Dam Repair Assessment

- Predominantly Stone Masonry Construction with Earthen Embankments
- Primary Spillway ~ 133 Feet Wide
- Canal Spillway ~ 51 Feet Wide
- Dam is a Significant Hazard (Class II) Dam
- Classified as a “Large” Dam Due to Volume of Impounded Water
- Reported Condition Varies, Actual Condition is Poor

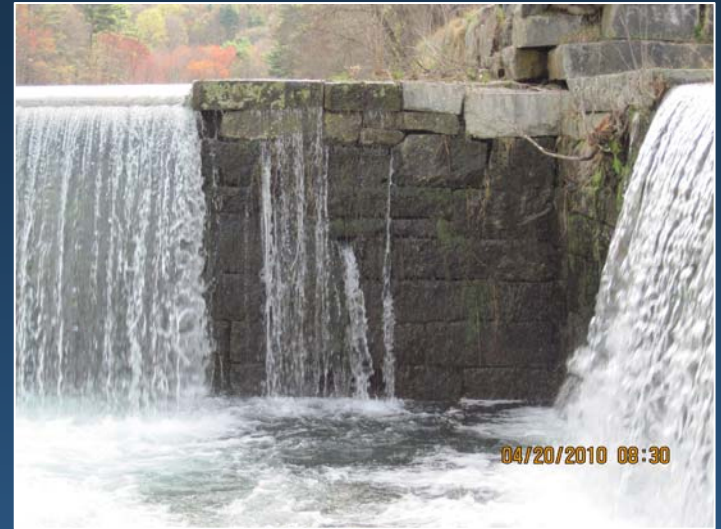
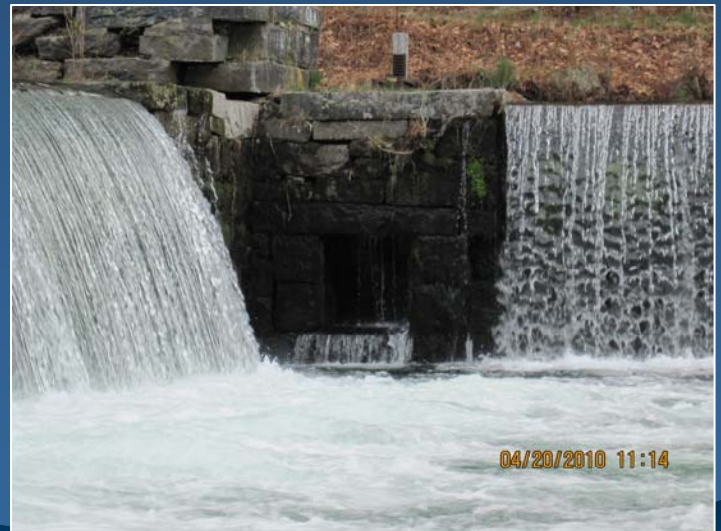
# Identified Deficiencies

- Excessive Leakage
- Cracks and Settlement on Right Training Wall
- Erosion on Right Embankment
- Displaced Riprap Armorment
- Deteriorated and Leaking Headgates on the Canal
- Inoperable Low Level Outlets
- Insufficient Spillway Capacity

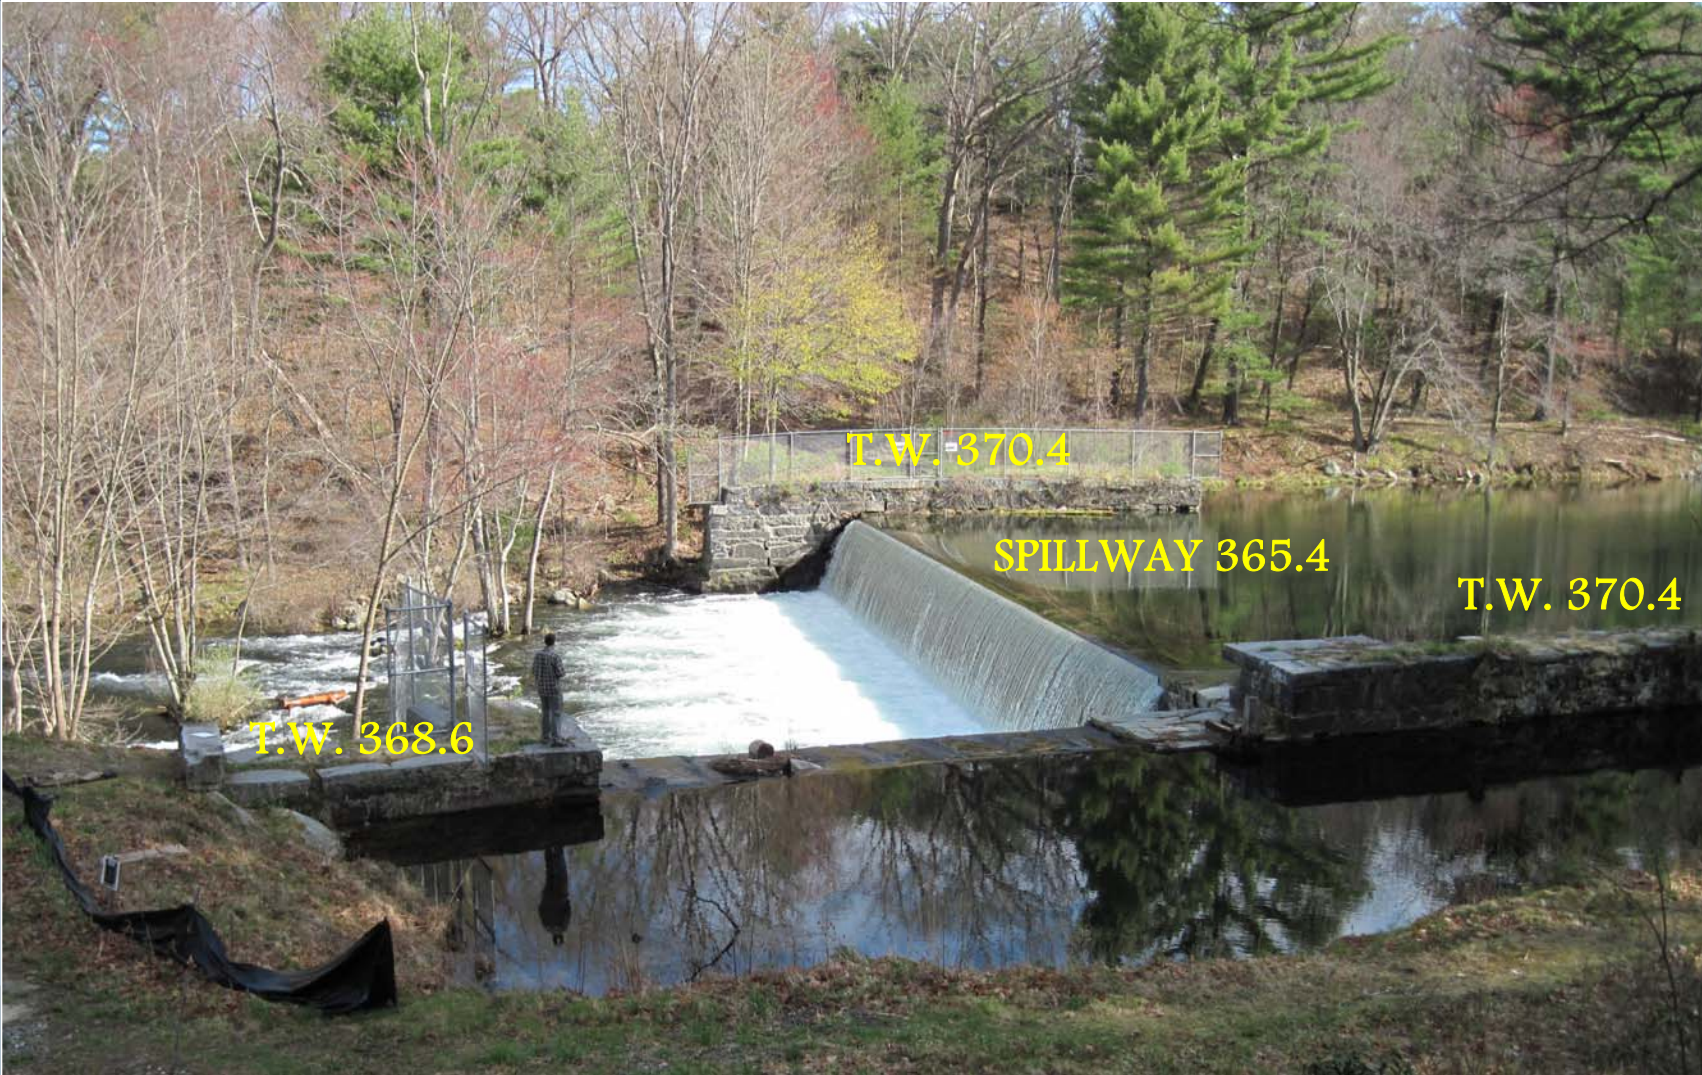
# Spillway Capacity

- Spillway Design Flood Design Storm
- Large – Significant Hazard Dam SDF = 500 Year
- Previous Reports SDF~Assume 5' of Water Over Spillway
- Change in Dam Geometry
- Spillway Capacity Limited to 2.5'
- Training Wall will Overtop Causing Possible Unraveling or Failure
- Dam Safety Recommends Freeboard Above SDF
