**ASSESSMENT OF THE
UPPER BONDSVILLE DAM**

**SWIFT RIVER
BELCHERTOWN, MASSACHUSETTS**

June 11, 2010

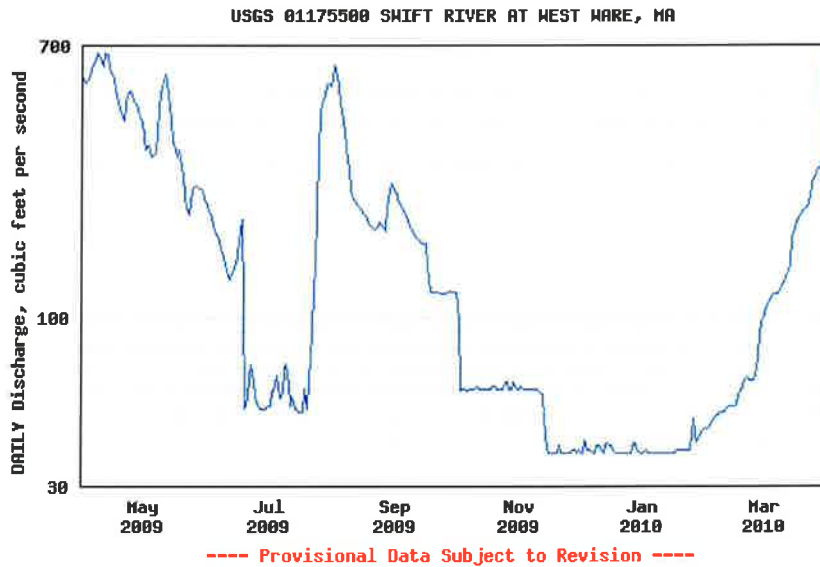
The U.S. Geological Survey (USGS) has continuously operated the Swift River at West Ware, Massachusetts gauge (#01175500) 1.4 miles downstream from the Quabbin Reservoir since 1910 (Lat 42°16'04", Long 72°19'59"). The drainage area of the contributing Swift River watershed at the gauge is 189 mi², which includes 1.6 mi² drained by Beaver Brook, the flow of which is diverted from the Ware River basin. Readings taken prior to January 1937 were for a watershed of 186 mi². The following figure shows recent flows at the West Ware gauge.

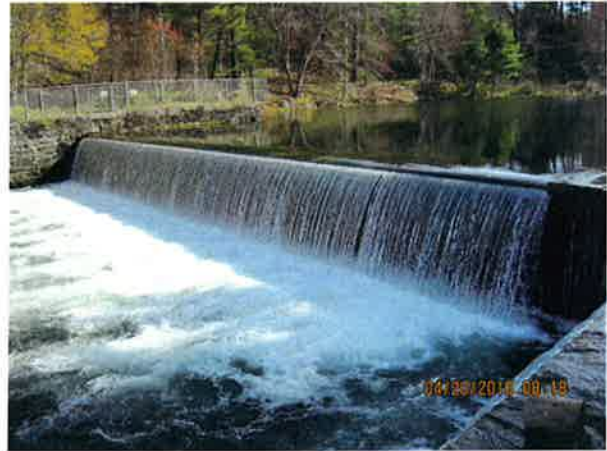
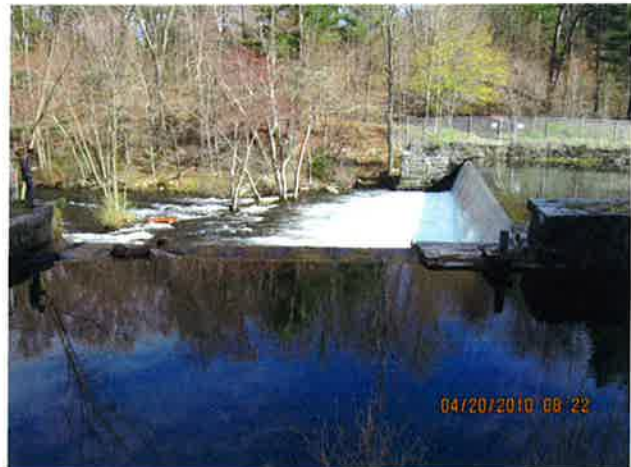
The main axis of the dam lies in a north/south orientation, perpendicular to the flow of the river. The river flows over the main spillway on the right or north side of the river. A training wall to the left or south of the main spillway extends in an east/west direction and divides flow between the main river and an old mill canal. The canal is located to the left or south side of the dam. Historically, it extended approximately 1,100 feet from the dam along the left side of the river to supply water to the then active mill buildings. In the mid 1990s, an earthen dike was constructed across the upper end of the canal following several drowning fatalities. The only hydraulic connection between the upper and lower canal appears to be a 12-inch plastic pipe that runs beneath the earthen dike.

The Upper Bondsville Dam is a run-of-the-river stone masonry dam. The impoundment behind the dam extends northward along the Swift River into the town of Ware on the east side and the town of Belchertown on the west side. The dam is located approximately 5.5 miles downstream of the Quabbin Reservoir and 3.5 miles upstream of the confluence with the Ware River. The Swift River flows generally in a southerly direction from the Quabbin Reservoir before turning westerly at the dam site. The dam is located to the north of Main Street and can be easily seen from the roadway. An old railroad bed parallels the river on the north side of the dam (right bank looking downstream). The closest bridge over the Swift River is located at Depot Street, approximately one-half mile downstream of the dam.
