# PRESENTATION

## Assessment of the Upper Bondsville Dam, Swift River Belchertown, Massachusetts

MILONE & MACBROOM®  
September 30, 2010

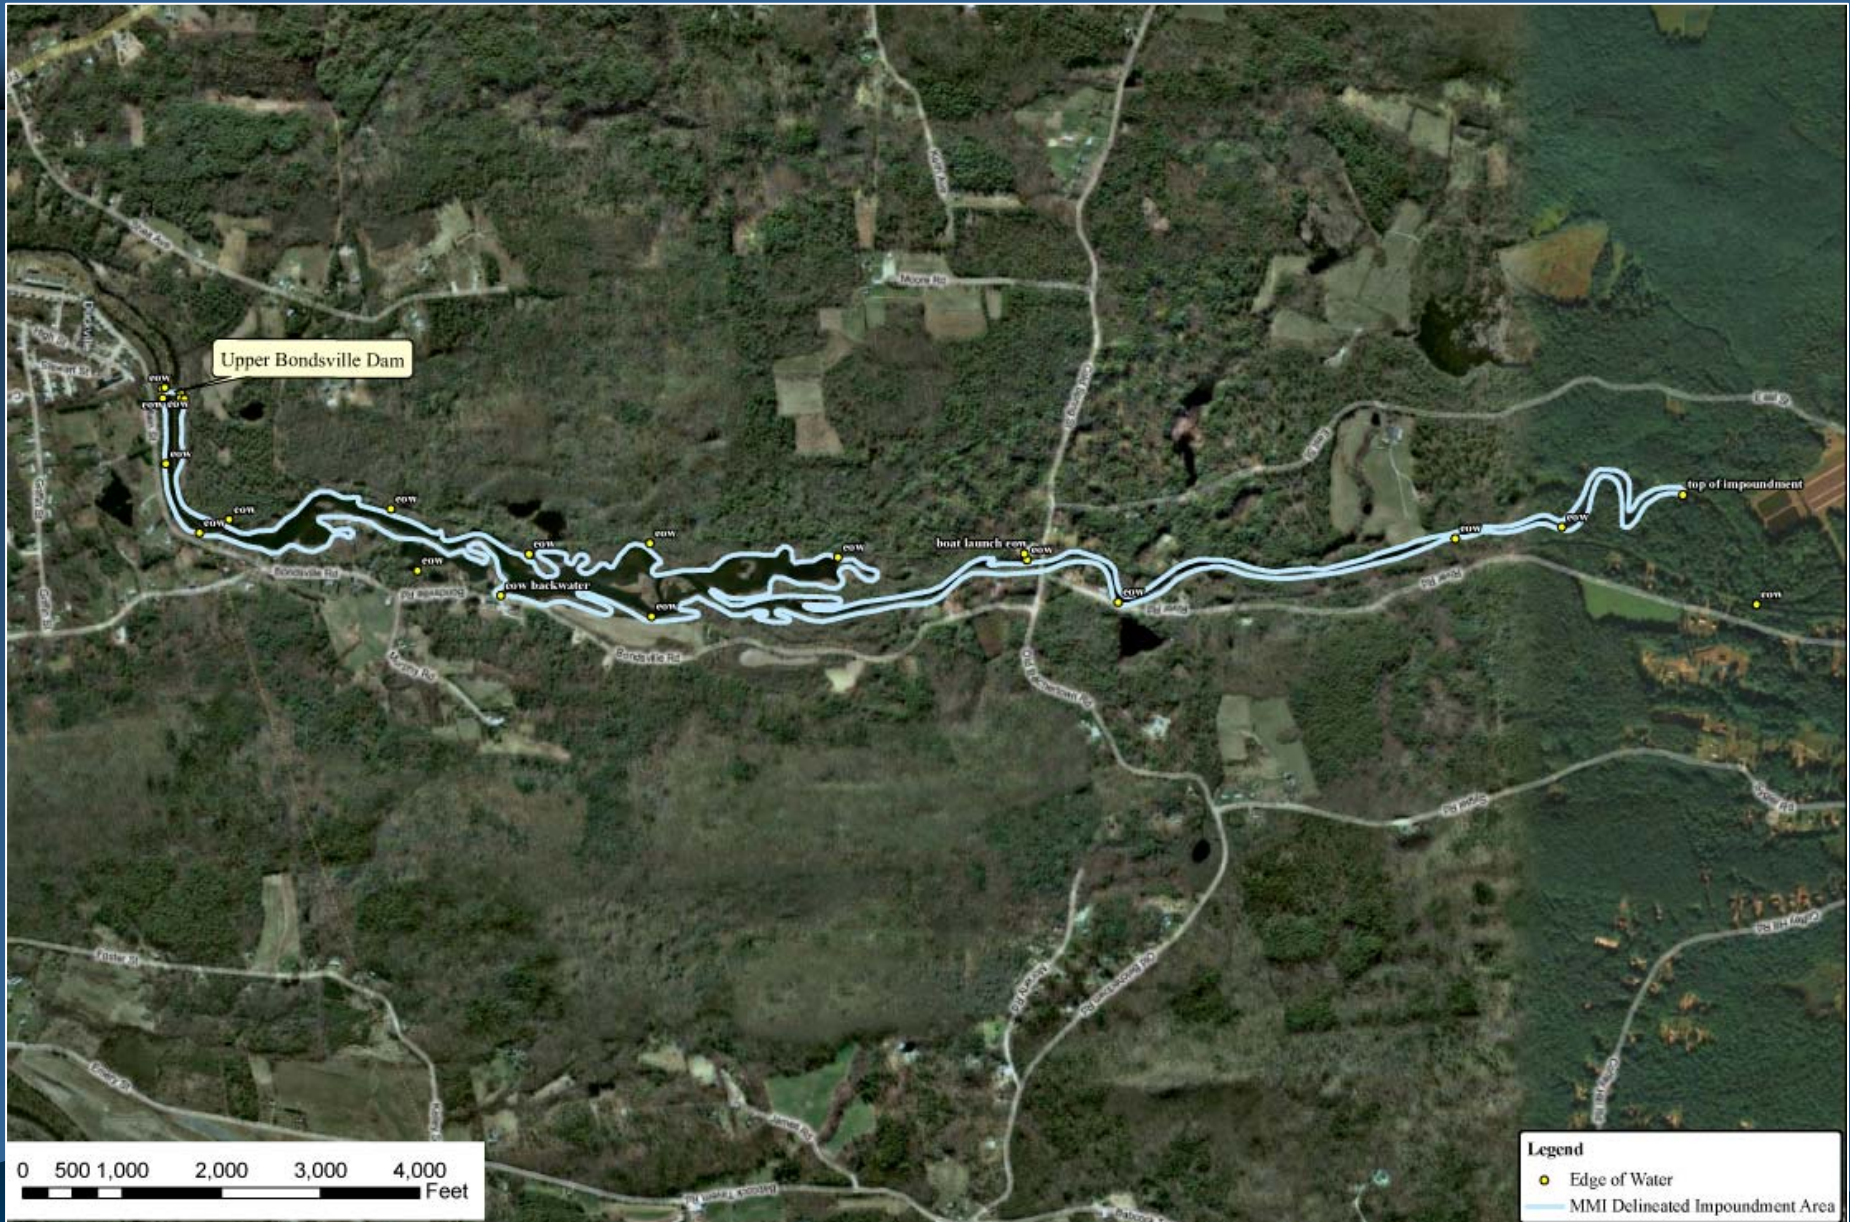
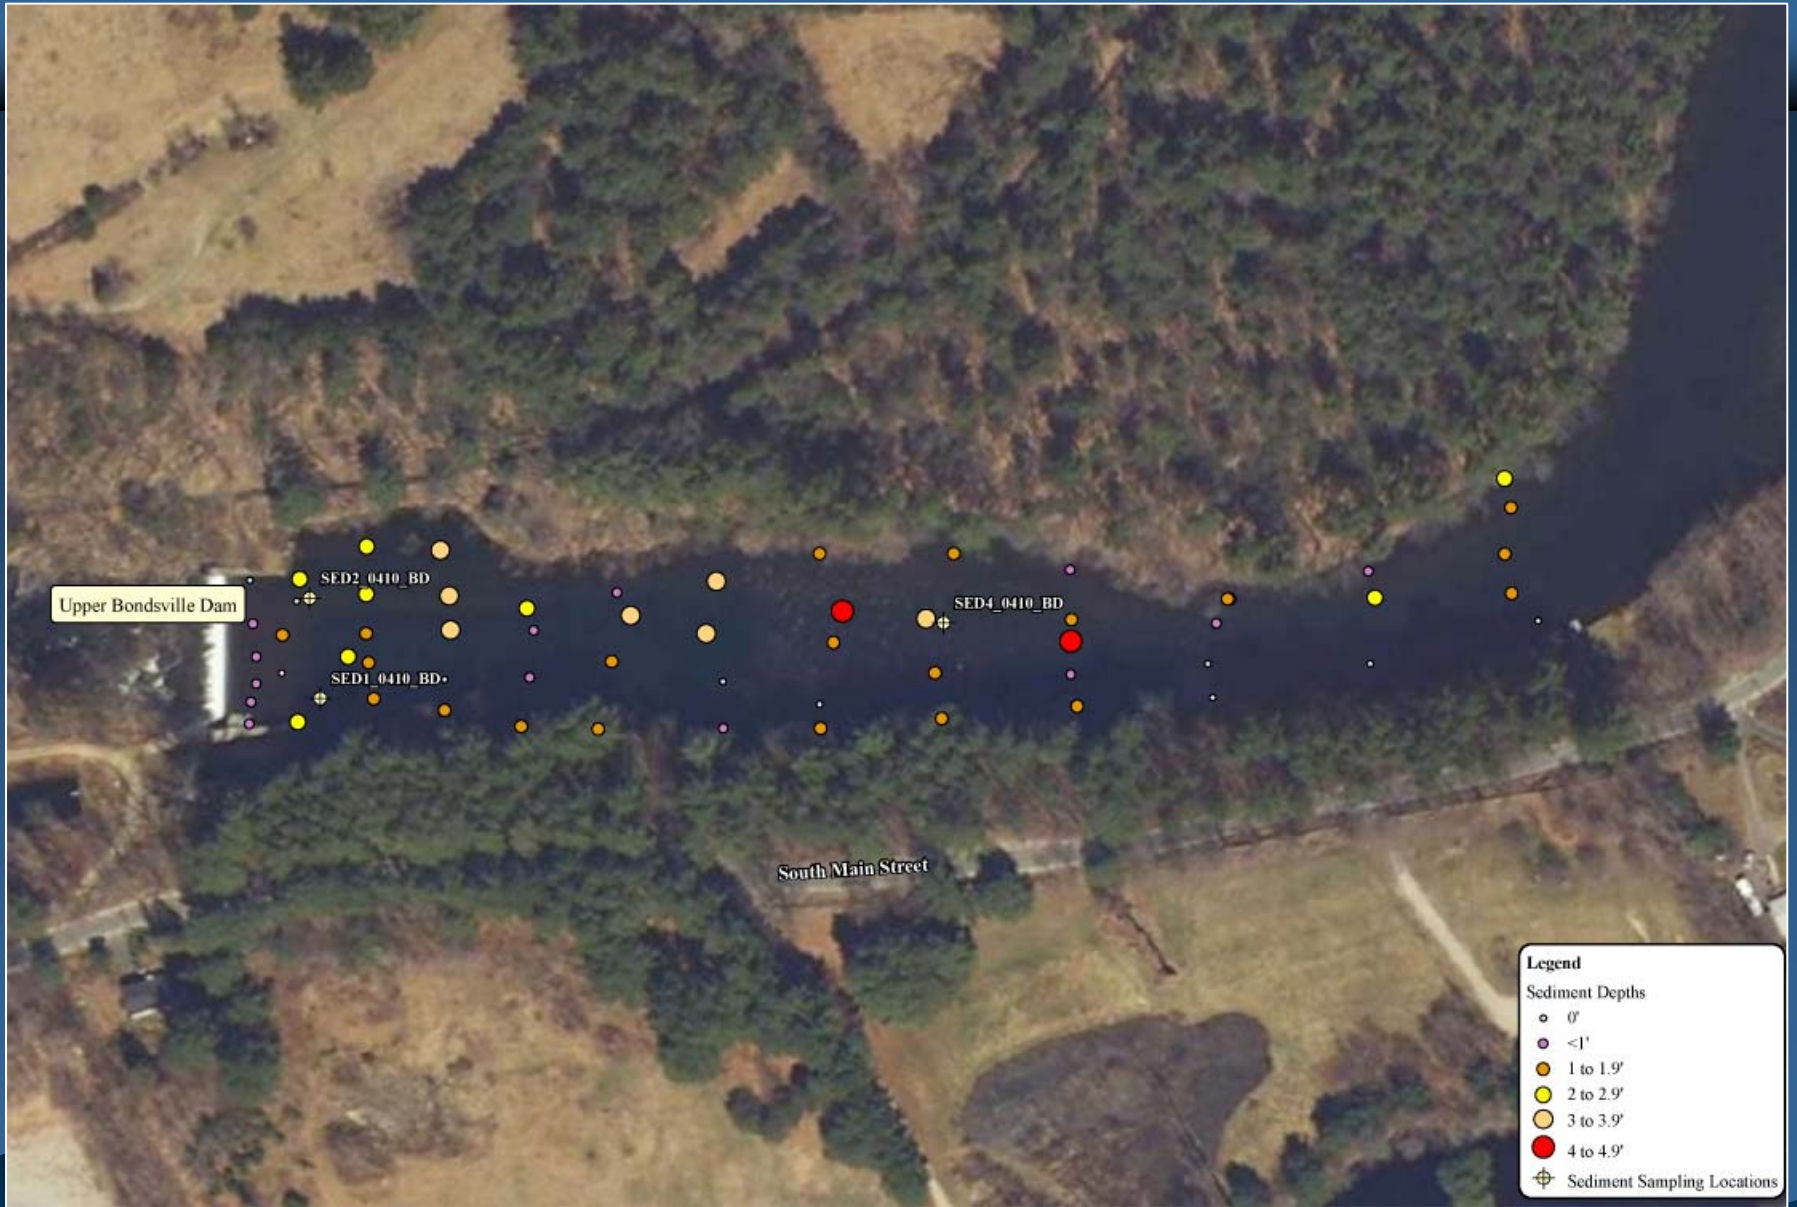
# Impoundment Delineation

- Previous Reports Identify Impoundment Extending 8,000 Upstream of Dam
- MMI Conducted Independent Investigation
- Observed Transition from Calm Pool to Faster Moving Riffles
- Global Positioning System Used to Map Impoundment Extent
- Lower vs. Upper Impoundment
- Hydraulic Modeling Would be Needed to Refine the Delineation
